Report to the Common Council Regarding 106-108 and 118 Newfield Street

Summary

Landslide

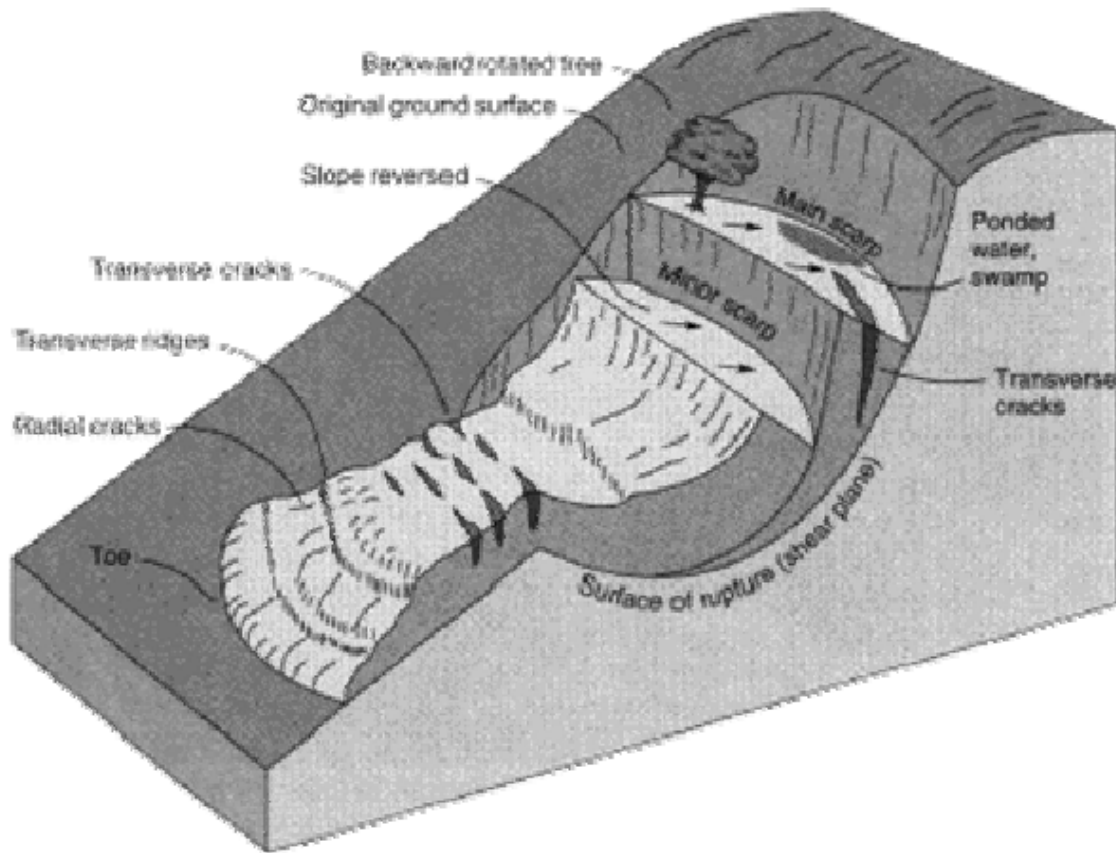
Diagram of a Debris Slide

The most accurate description of the event is something that is known as a debris slide. This is a “slide of coarse-grained soil, most common in unconsolidated sandy or gravelly units, but also are common in residual soils that form from in-place weathering of relatively hard rock. Owing to the granular constituents, overall strength of the debris slide mass generally is higher than that of earth flows, but there may be a very low strength zone at the base of the soil or within weathered bedrock. Debris slides typically move initially as shallow intact slabs of soil and vegetation, but break up after a short distance into falls and flows. Movement of the slide mass as a shallow slab leads to a smooth, steep, commonly curved scar. The debris is deposited at the base as a loose hummocky mass, although the deposit may be rapidly removed by erosion.

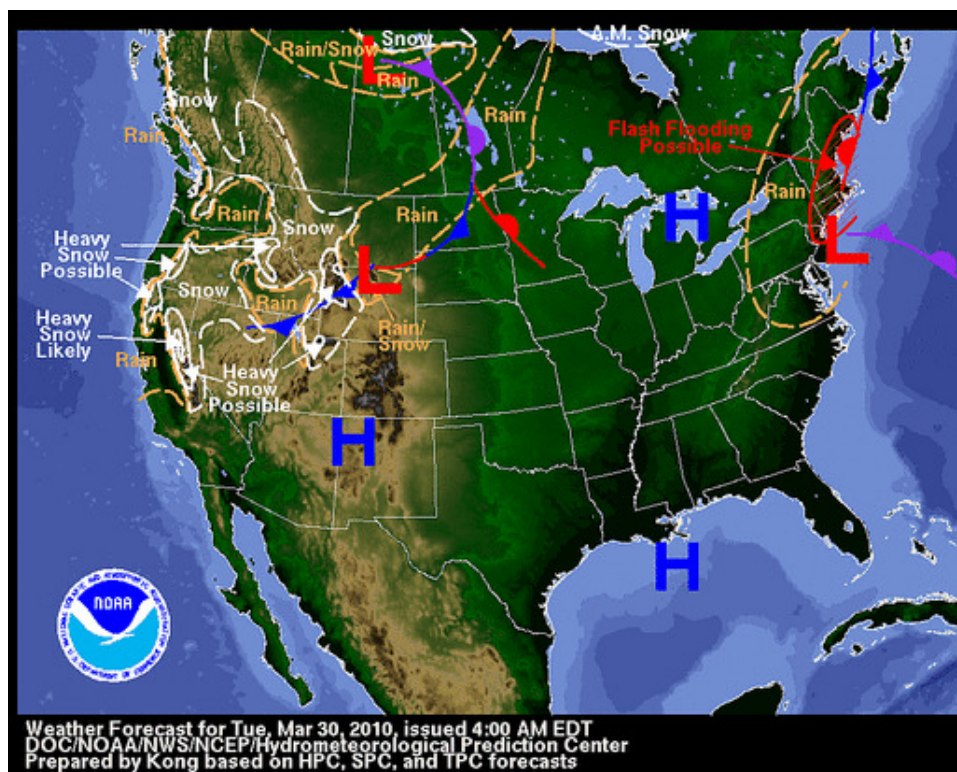
History for KCTMIDDLE5

March 2010 was a particularly active weather month with 15 days of precipitation. Four of those days had flash flood warnings issued by NOAA, which included the day of the landslide. The month experienced 9.56 inches of rain, the average for March is 4.55 inches. During this time the Connecticut River exceeded its flood stage of 8 feet and set a new record for the 20th highest recorded level at 12.96 feet on April 2, 2010. These conditions certainly fully saturated the toe of the slope perhaps more than ever before.

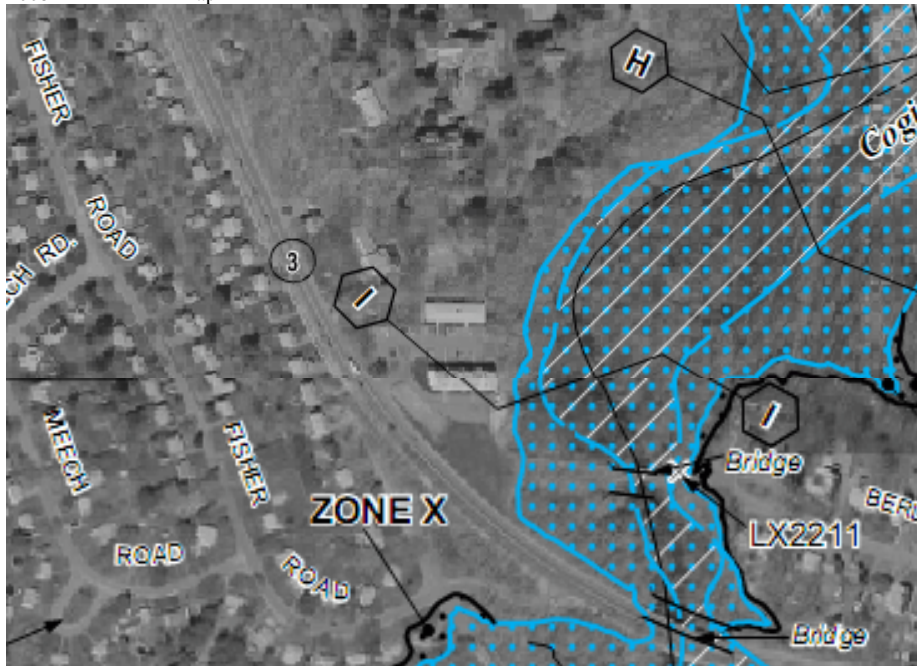
2008 FEMA FIRM Map

The 20 unit building is located outside 2008 delineated floodplain zone (Firm Panel 0108G, Aug 28, 2008). The 2001 flood maps are less precise, in that they do not overlay an aerial photo. The Zoning Code, Section 46 at the time did not allow residential within a floodway or flood zone. The addition was located outside of these regulated areas, and therefore were not required to comply with these rules.

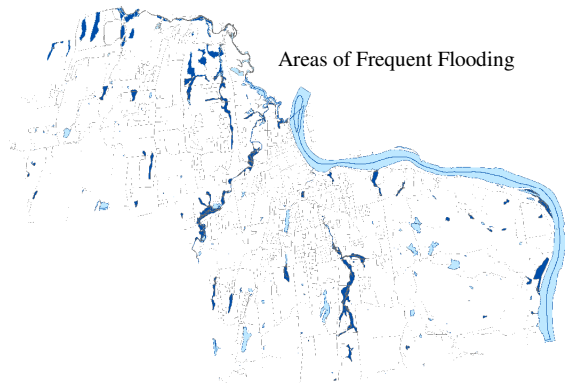
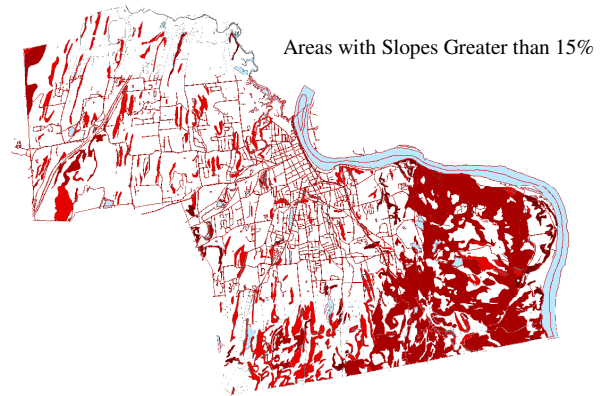
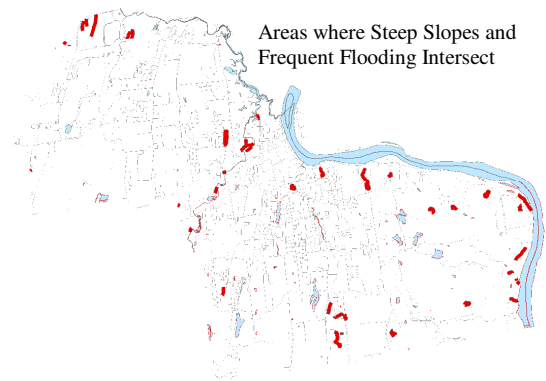
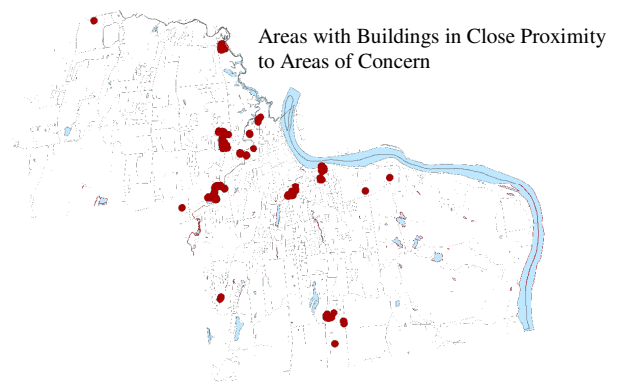
The following four maps show the locations of frequent flooding, areas with steep slopes, where they intersect and buildings in close proximity to these areas. 106-108 and 118 Newfield Street is one of the locations that is situated near an area of frequent flooding and steep slopes. Looking at other similar areas can help determine cause, either site characteristics, particular activities or other important data.

In reviewing the possible areas that this situation may be replicated, a location to the west of George Street reveals similar characteristics of steep slopes and frequent flooding. There have been drainage and flood concerns on George Street for years. This location is of interest, because of an event from October 1, 2006. On October 1, 2006, the construction site of Knoll Crest Apartments experienced a high amount of rainfall, 4.5 inches. This resulted in significant run-off of soil that overwhelmed George Street and clogged catch basins. The site was previously forested, but had recently been clear cut for the construction of the apartments. The 23 acre property without adequate vegetation and the heavy rains, over four inches that day, fell within period of less than two hours, liquefied the exposed soil and overwhelmed George Street below. The property did have erosion controls in place, but the attorney of the development described this as “an act of god”, and the required silt fences were not enough to maintain the run-off on the property.

In reviewing the other locations, many of them seem to not reveal any concerns, therefore it can be concluded that siting a structure within the letter of the law alone does not result in these types of events. Rather what the Newfield Street and George Street events reveal is that a significant rain event coupled with site activities can produce the possibility of either a landslide or a significant run-off event.
